Banking on protection

Levee repairs work to limit flood potential of Sacramento River

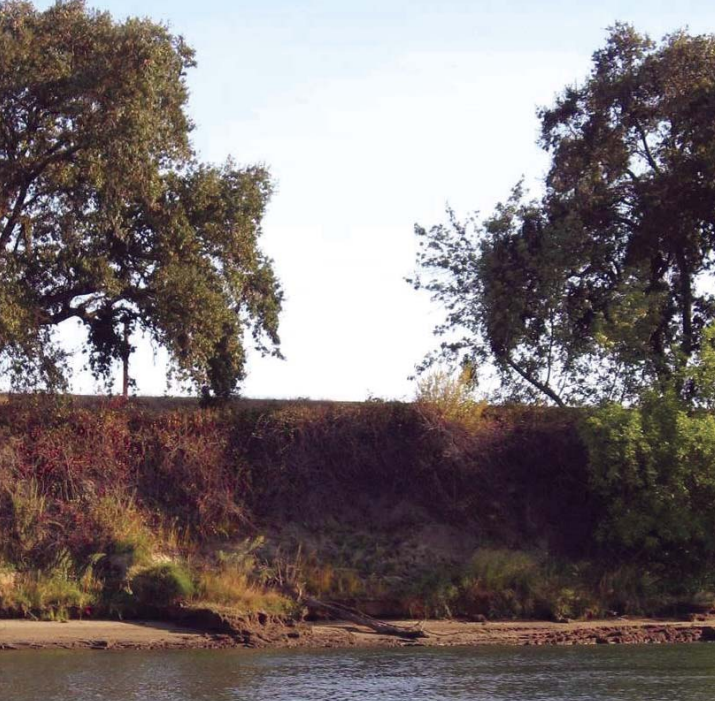
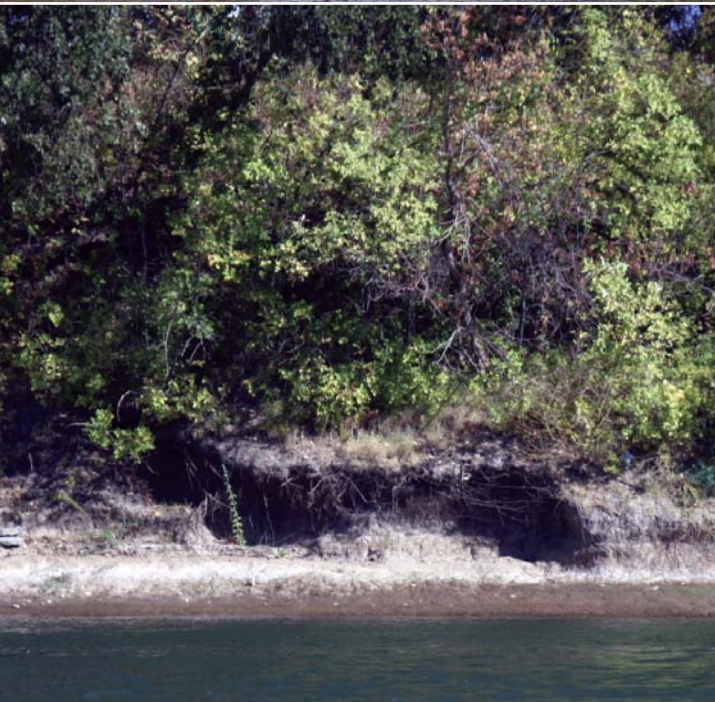
Left top and middle: Erosion along the Sacramento River banks threatens the integrity of the levee system. Left bottom: This image shows a quarry stone toe under the water surface and benches, or berms, above the water surface to provide for environmental mitigation. Right: Levee repair on the American River, a tributary of the Sacramento River, was conducted during the summer low-flow season.

During these site investigations, the Ayres Associates team found critical erosion sites where the river was eroding into the toe, or base, of the levee. Given the growing concern for levee stability after Hurricane Katrina, design and repair of the critical sites were put on a fast track in 2006. Ayres Associates completed plans and specifications for repairs to five critical erosion sites in a matter of months, allowing construction to begin in summer 2006.

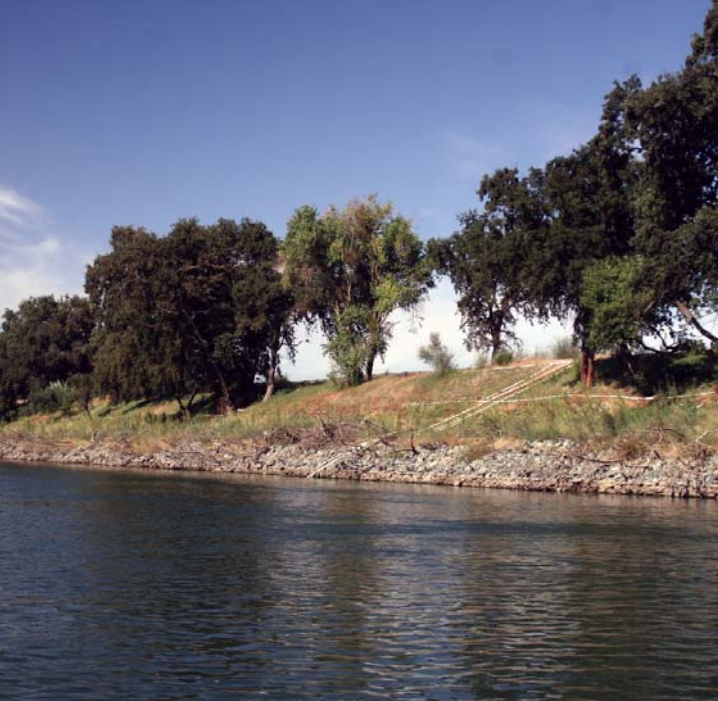
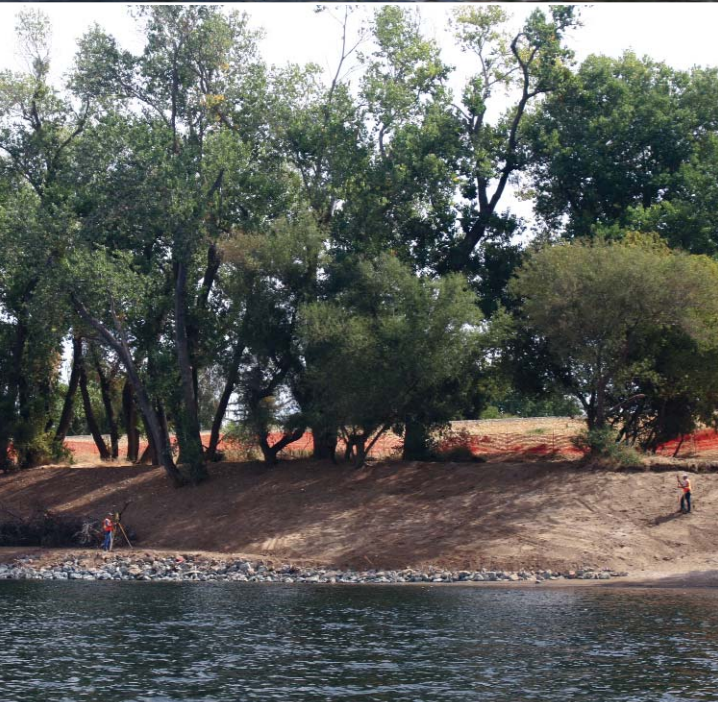
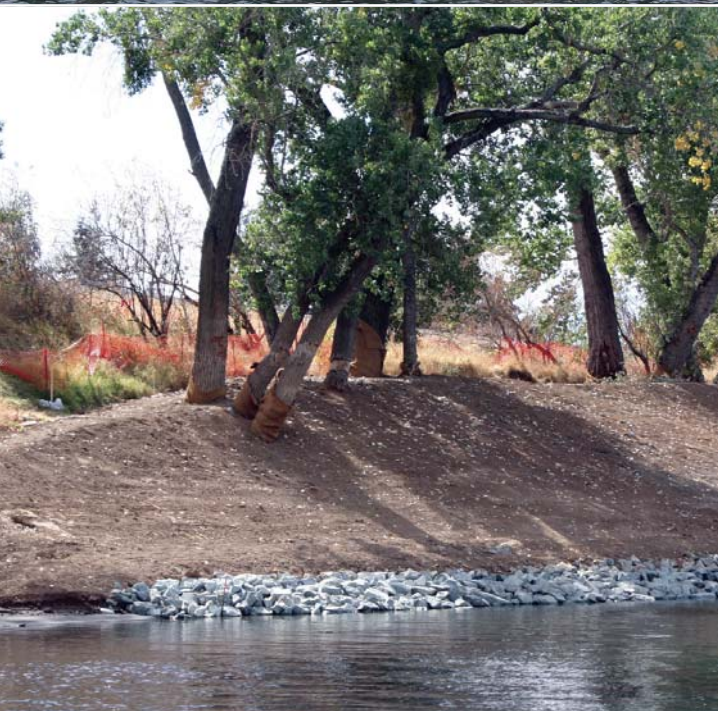
Left top: A completed levee repair site on the Sacramento River showing vegetation growth. Left middle and bottom: Wherever possible, trees were saved to provide shade on the water for fish and other wildlife. Right: Large woody debris at the base of the riverbank provides habitat for migrating salmon and steelhead during the winter's high-flow.

Maintaining function and appearance of the natural environment was a priority. Woody debris at the base provides habitat and shelter for migrating salmon and steelheads. Rock was infilled above the water line with a mix of soil to allow replanting of low-growing shrubs and grasses. Trees were saved to provide shade on the water. Elderberry shrubs, home for the endangered Valley elderberry longhorn beetle, were transplanted. When feasible, the design included berms or benches along the waterside slope where willows and shrubs could be planted.
