Calming the Waters:

Hydraulic analysis marks start of rebuilding
after bridge collapse

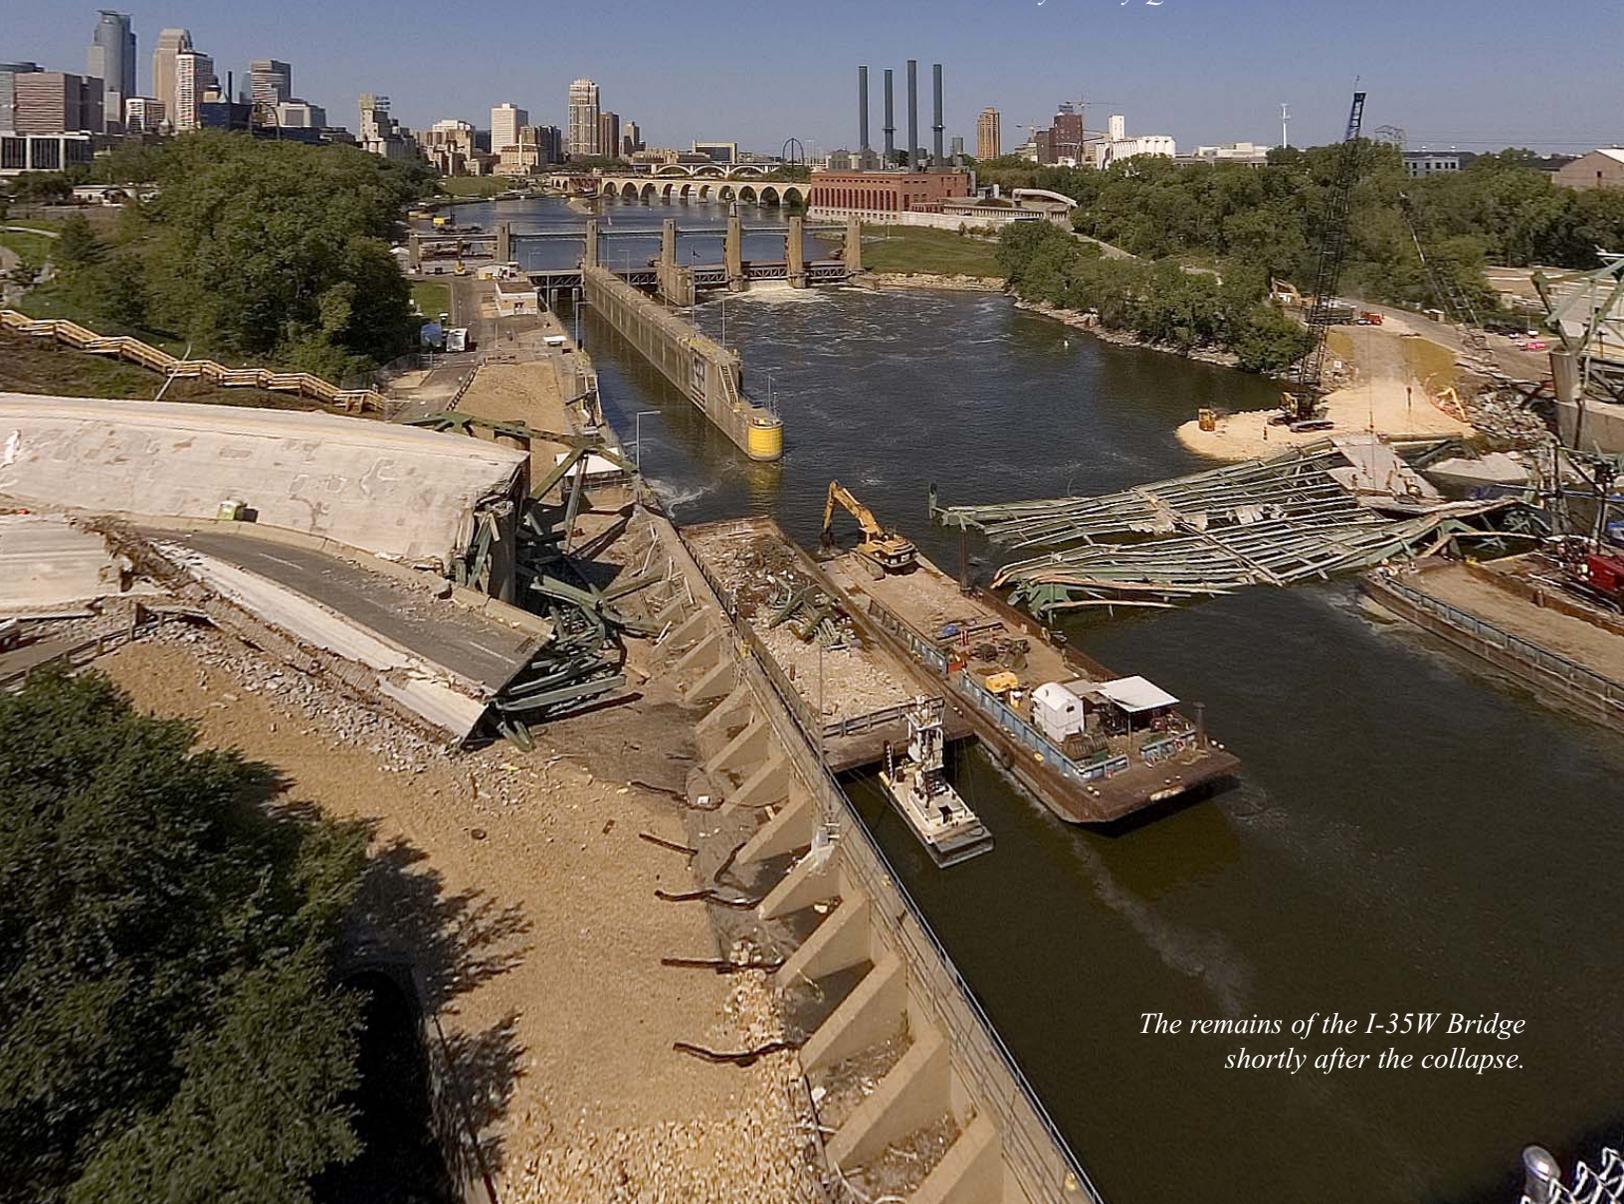
*The remains of the I-35W Bridge
shortly after the collapse.*

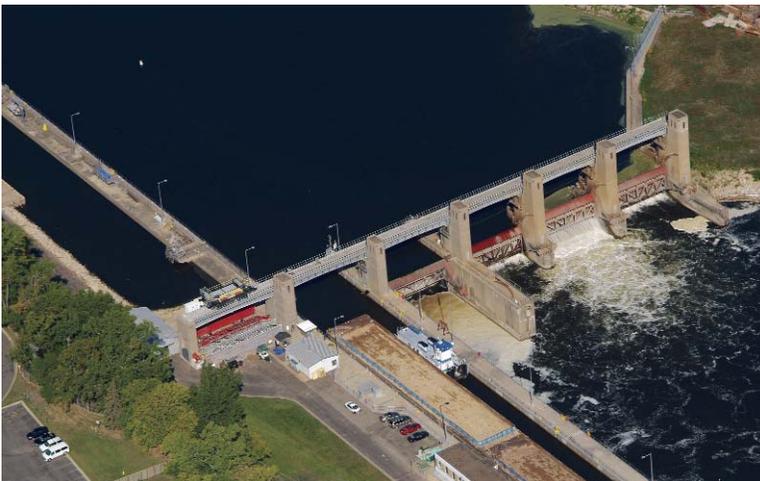
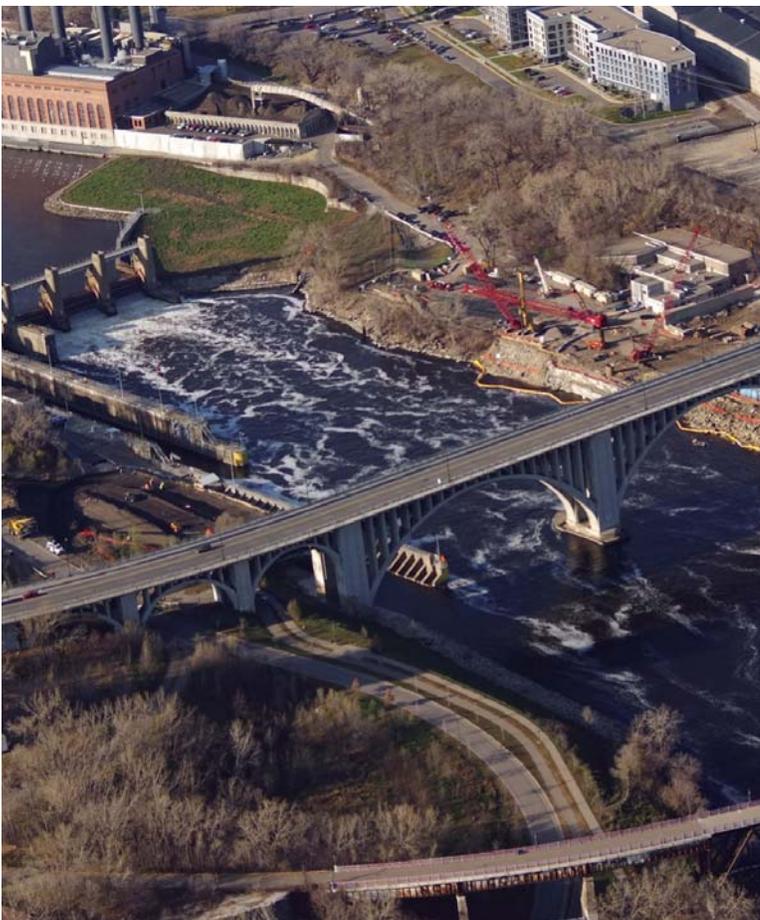
Bottom: The hydraulic analysis showed that the new bridge would not adversely impact the adjacent lock and dam facility, middle, or the 10th Avenue Bridge, bottom.

needed to demonstrate that the I-35W Bridge would not have negative impacts on nearby structures, including the downstream 10th Avenue Bridge, a nearby storm tunnel, or the adjacent U.S. Army Corps of Engineers (USACE) lock and dam facility. Finally, it provided information that was used in the scour analysis performed by Ayres Associates.

Additionally, one of Mn/DOT's requirements was that the downstream 10th Avenue Bridge pier, which is in the middle of the river just downstream of I-35W, would not be harmed by the new bridge. "The 10th Avenue Bridge is scour critical," said Andrea Hendrickson, state hydraulics engineer for Mn/DOT. "We were very concerned about negatively impacting that bridge." The scour analysis was able to show that the velocity of flow impacting the pier and the potential scour would not change based on the new bridge.

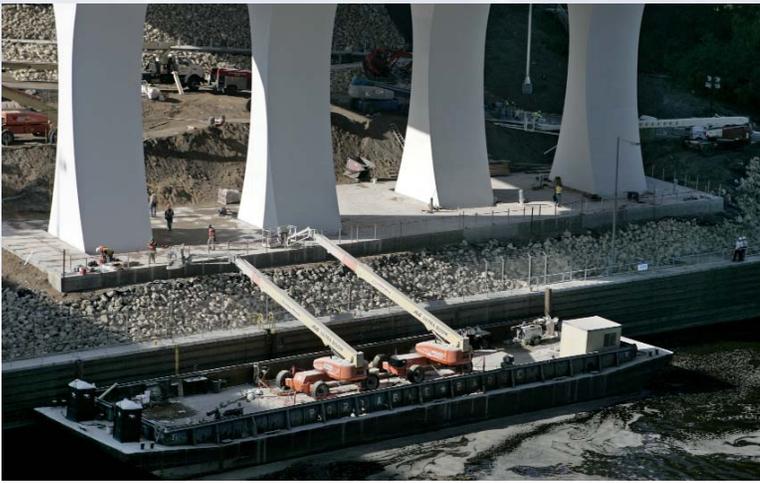
Top: Pier No. 2 on the south bank by the lock and dam facility. Middle: A storm tunnel near the new pier increased the complexity of the hydraulic analysis. Bottom: Construction crews put the finishing touches on the new I-35W Bridge, which opened to traffic on September 18, 2008, 11 months after construction began.
